ALASKA LNG PROJECT	DOCKET NO. CP17-____-000 RESOURCE REPORT NO. 13 LNG APPENDICES PART 15 OF 19	Doc No: USAKE-PT-SRREG-00- 000006-000 APRIL 14, 2017 REVISION: 0
	PUBLIC

LNG FACILITIES MARINE GEOTECHNICAL DATA REPORT

LNG FACILITIES MARINE GEOTECHNICAL DATA REPORT MARINE LNG FACILITIES ALASKA LNG PROJECT NIKISKI, ALASKA

AKLNG DOCUMENT NO. USAL-FG-GRZZZ-90-002015-011

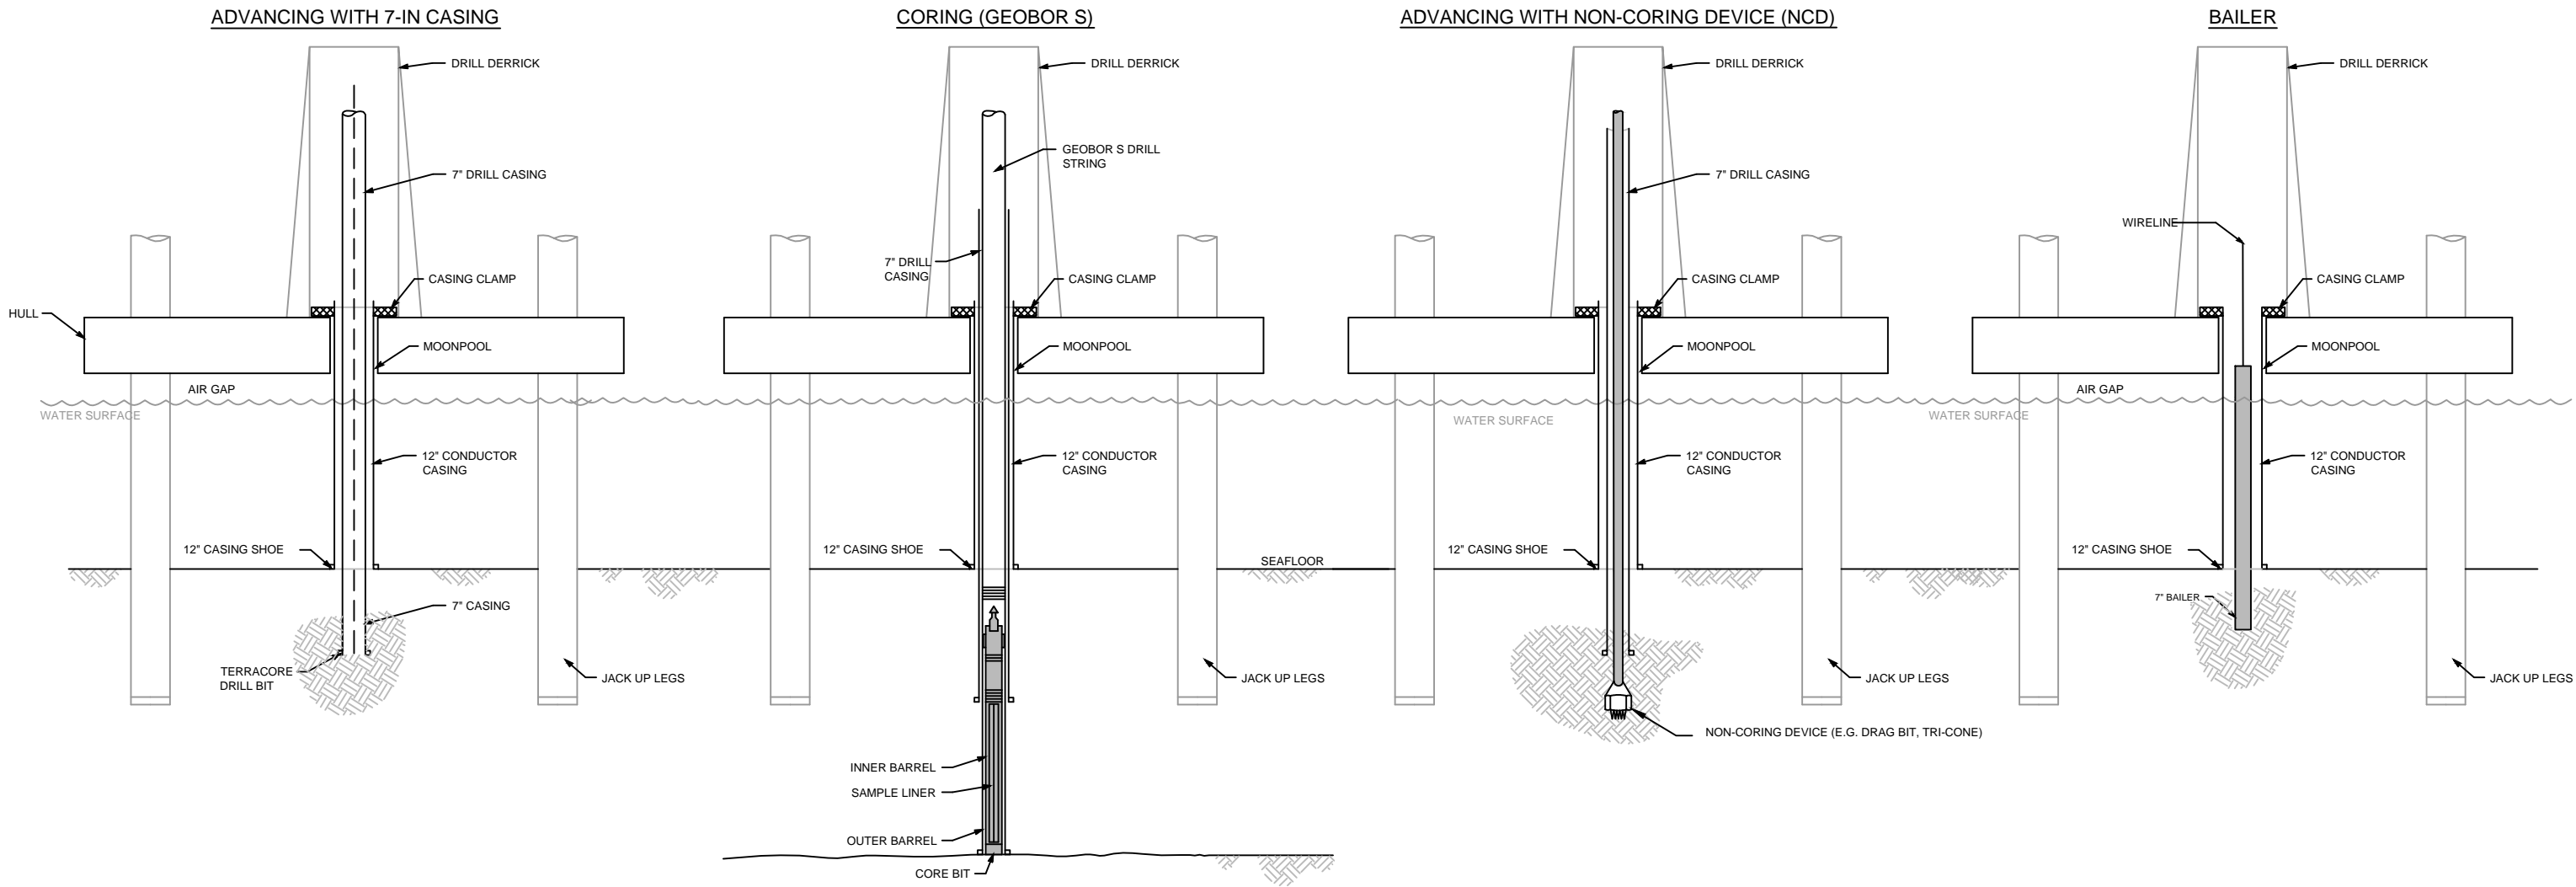
**SCHEMATIC FOR BOREHOLE ADVANCEMENT
MARINE LNG FACILITIES
ALASKA LNG PROJECT
NIKISKI, ALASKA
(NOT TO SCALE)**

Once hard/dense soil conditions were encountered triple-tube Geobor S 146 mm OD (5¾ in OD) wireline coring assembly was deployed and drilling was accomplished by rotary drilling procedures in general accordance with the Standard Practice for Diamond Core Drilling for Site Investigation (ASTM D2113) to achieve the sampling depths per above mentioned requirements. The wireline core assembly allows quick retrieval of the inner core barrel from the downhole core/drill string using a hydraulically operated wireline winch and an overshot retrieval tool. The hard/dense soils were generally continuously cored at 5-ft intervals to total depth. However, depending upon the soil characteristics (e.g. presence of cobbles, boulders affecting recovery) and in order to achieve the desired sampling depths, some core runs were shortened. Full core runs 5 ft were re-established as conditions permitted. When desired sampling depth was reached NWY assembly with SPT or thin wall tube was run inside the Geobor string for further sampling. Additional samples (i.e. grab samples) were saved from the cores collected as part of Geobor drilling techniques in order to refine the stratum descriptions. Both the driller and the engineer/geologist on shift generated accurate logs of all activities performed, observations during drilling and all recovered soil samples.

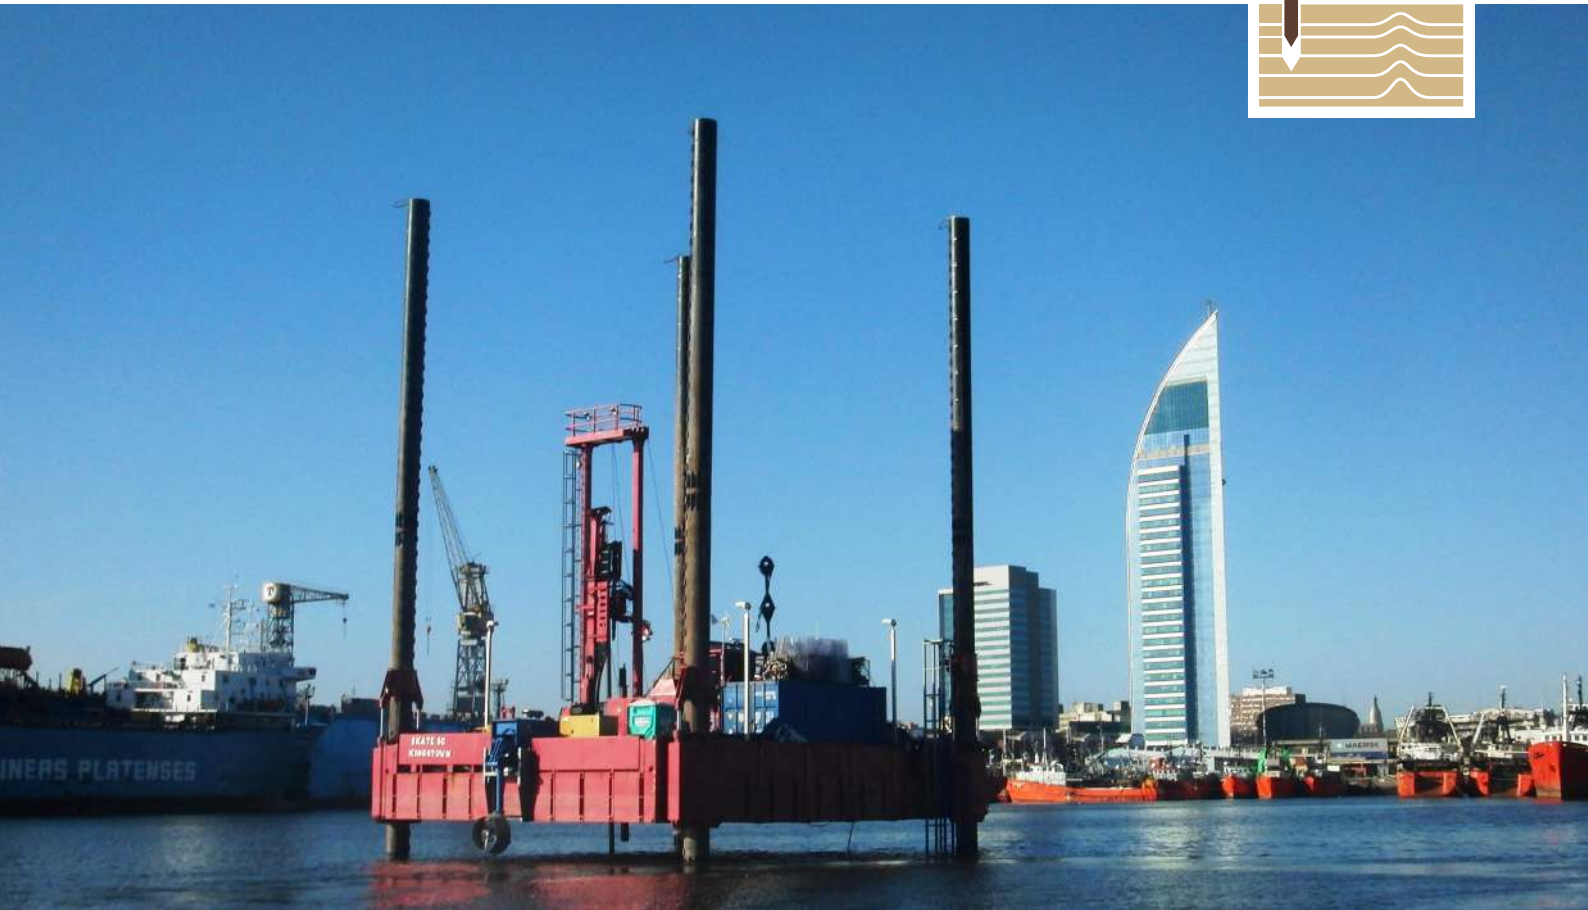
FUGRO SEACORE SKATE 3

The Skate 3 range consists of medium sized, high payload, container transportable jack-up platforms. These platforms have a low international transport cost coupled with high performance capabilities.

Operated and maintained exclusively by Fugro Seacore's trained and experienced marine engineers, the Skate 3 jack-up is a versatile, stable, self-elevating platform for overwater work.

Max Separation:	32m
Working Draft:	0.985m
No. of Containers	7
Deck Area:	238.1 sq m
Leg Size:	762mm
Elevating System:	Hydraulic Ram & Duo Pin Rack
Accommodation	Workshop/canteen container

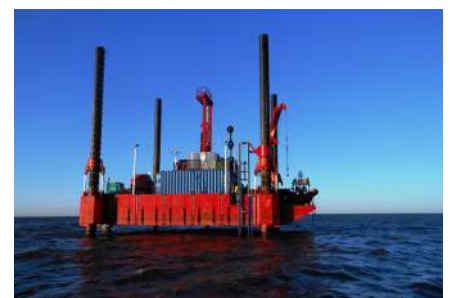
Skate 3 on site in Uruguay.

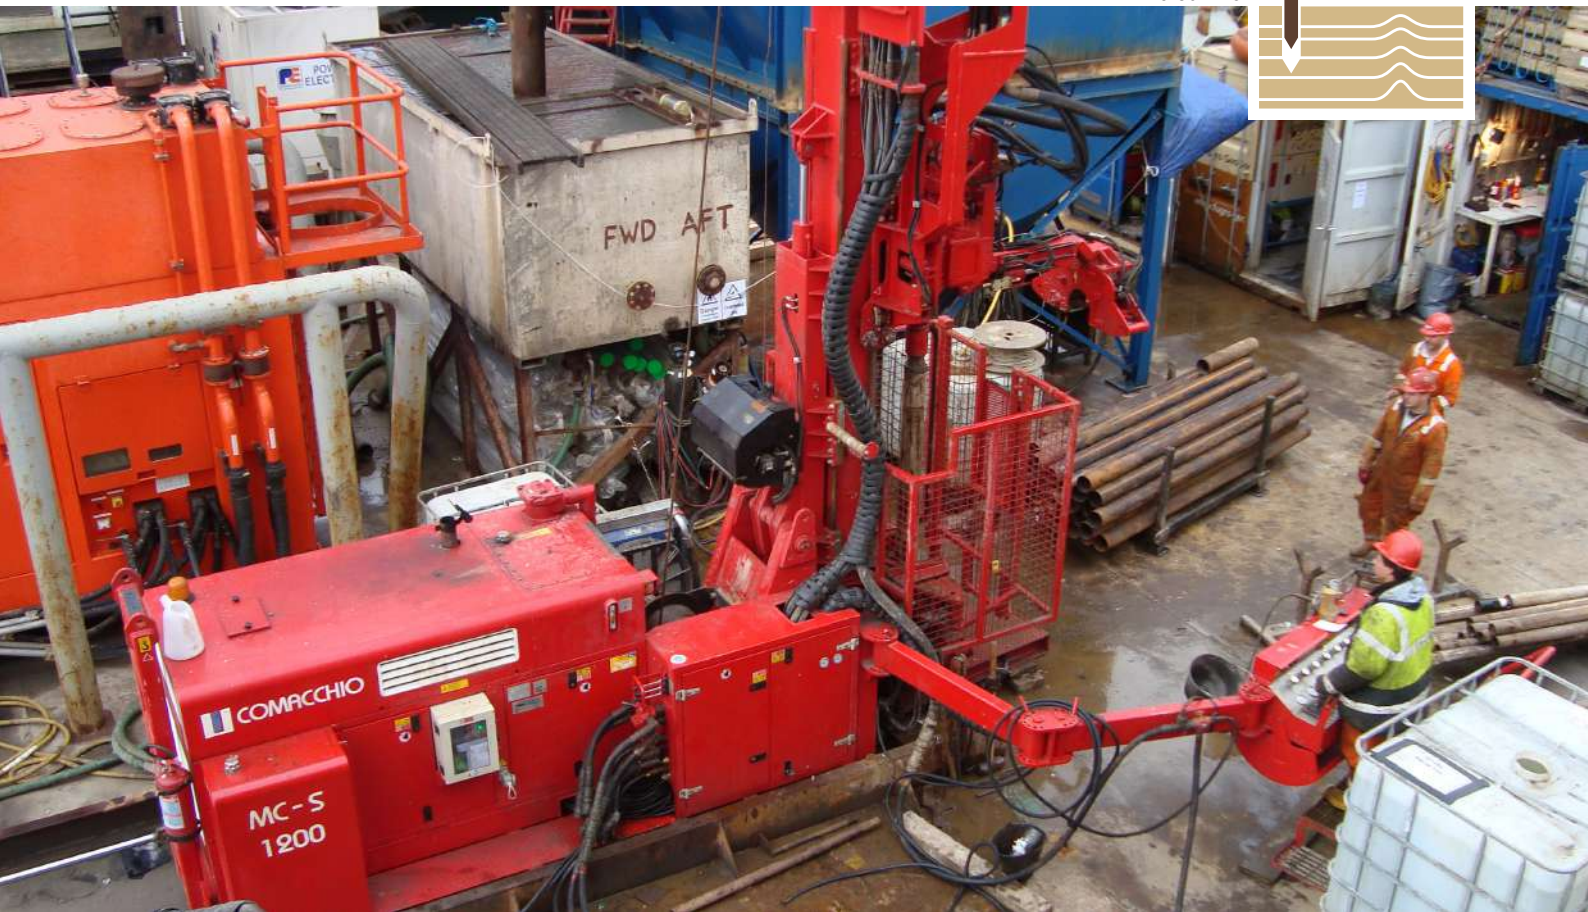
FUGRO SEACORE COMACCHIO MC1200

The MCS 1200 is a hydraulic skid mounted drilling rig capable of operating all rotary and/or rotary percussive drilling systems.

The MCS 1200 is suitable for all aspects of rotary soil investigations, core drilling as well as specialised civil engineering works such as micropiles, anchors and ground consolidation works.

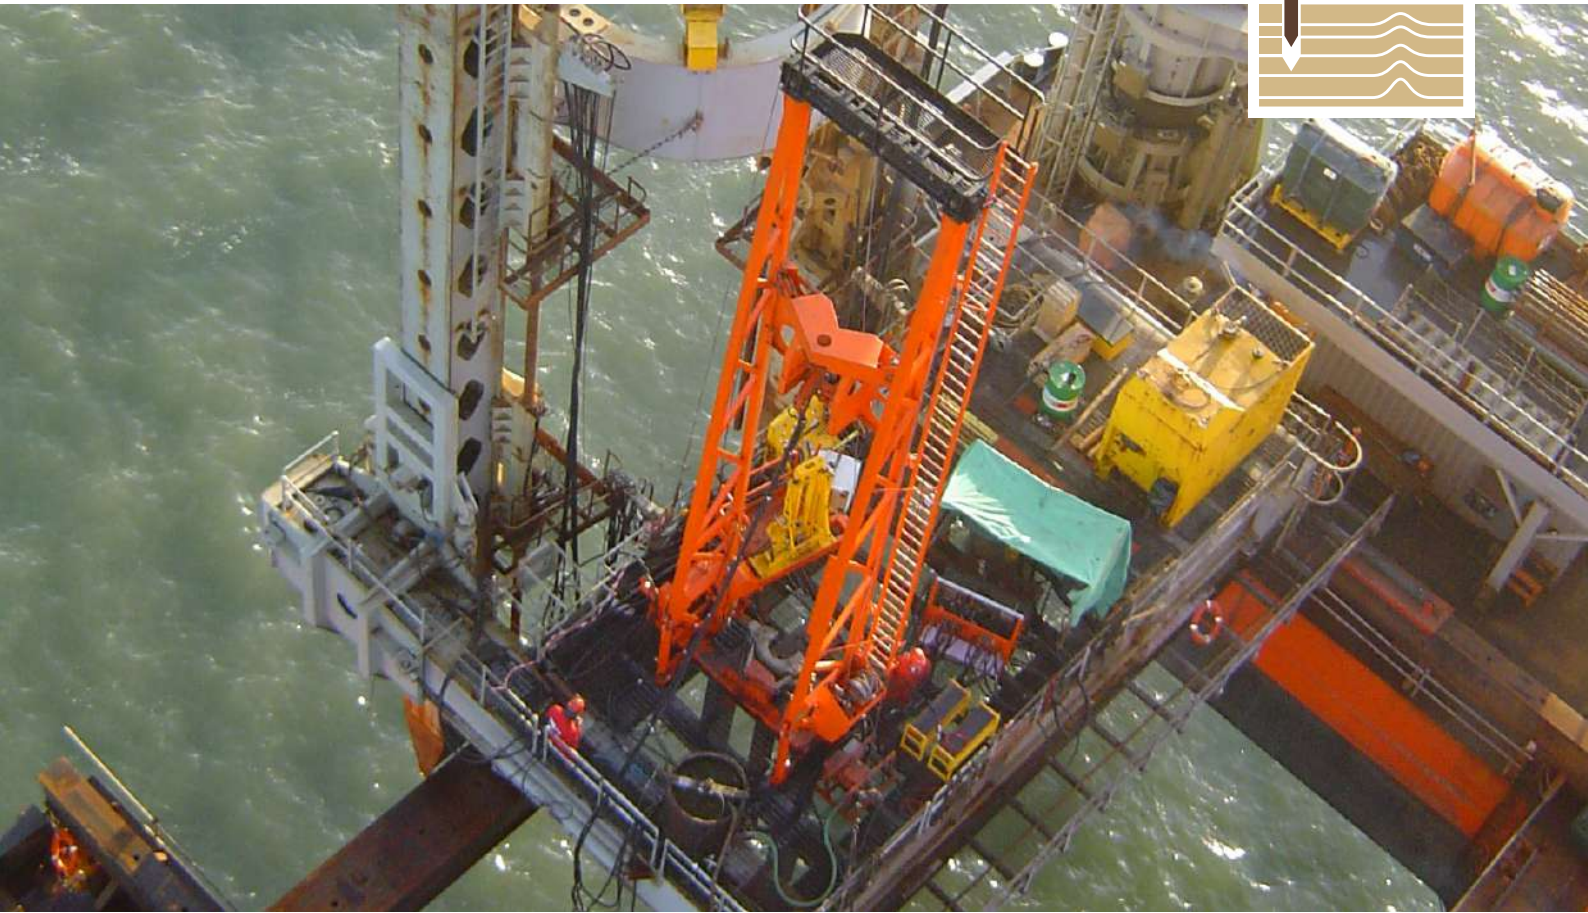
FUGRO SEACORE CR2 MARINE DRILL

Fugro Seacore's specialised inshore marine drilling mast CR2 is a multi-purpose, twin 'A' frame mast measuring 12m x 2.1m. It is designed to reduce the unproductive, labour intensive operations normally associated with overwater drilling.

Conventional or wireline cores can be carried in a variety of sizes.

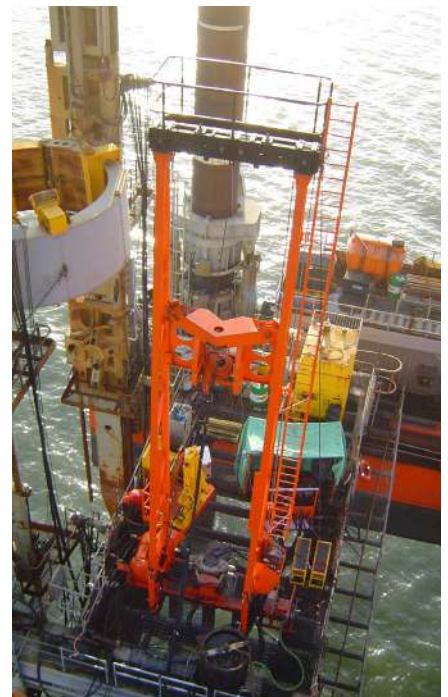
For rotary open-hole drilling the boreholes are excavated without conductor or liner casings. Stability of the unlined holes is provided by drilling muds which are guar-based, non toxic and bio-degradable.

CR2 Marine Drill at Barrow OWF

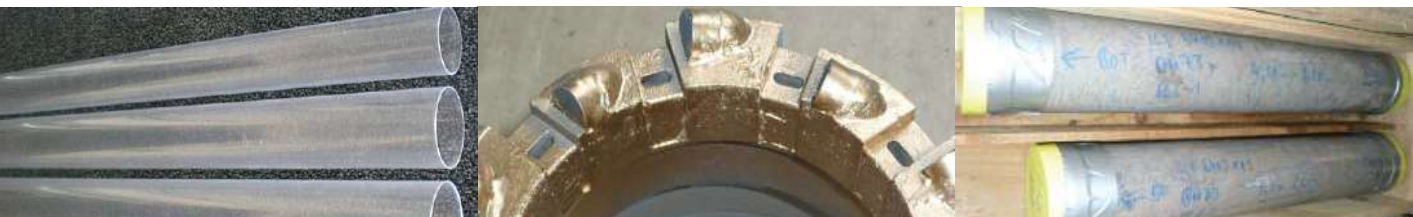
GEOBOR-S triple tube wireline drilling system which has been specially developed for high quality geotechnical investigations of soil and rock formations

The core barrel itself is designed for flushing with water, mud or air, and can easily be adapted for most soil and rock conditions by the use of an appropriate core bit or non coring devise.

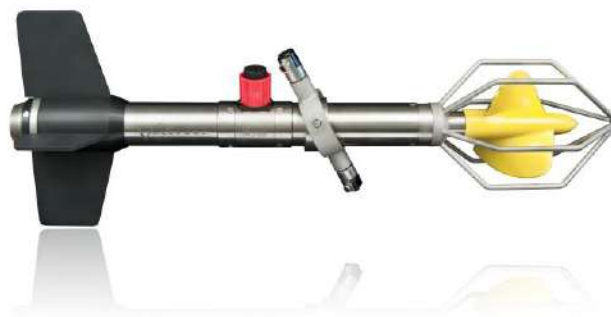
512 Kbyte Solid State Memory. Each parameter record uses 2 bytes. As an example, this gives a duration of over 1 week with full parameter sampling every 10 seconds, or 220 days with sampling every 5 minutes.

Internal: 1 x D cell. 1.5v alkaline cell gives approximately 30 days at 10 second sample rate, or 56 days at 5 minute sample rate. 3.6v Lithium cell gives approximately 90 days at 10 second sample rate, or 180 days at 5 minute sample rate.
 External: For external supply, 12-20v DC is required. Power can also be taken from the Model 8008 CDU.

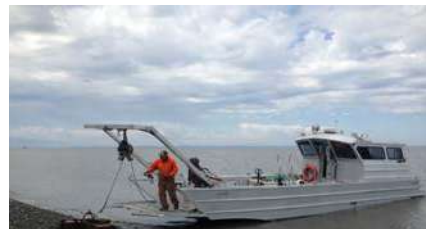
VESSEL PARTICULARS

LENGTH OVERALL 42'
 BEAM 10.5'
 DRAFT 3'
 22' X 9.5 FOREWARD WORK DECK
 30 KNOT CRUISING SPEED
 200 GALLON FUEL CAPACITY
 200 MILE RANGE
 6,000 LB CARGO CAPACITY
 LANDING CRAFT STYLE BOW GATE
